**Immediate Response Action  
Status Report No. 3** (DEP RTN 3-  
23246) **and Immediate Response  
Action Status Report No. 1** (DEP  
RTN 3-26114)  
50 Tufts Street, Somerville, MA

Submitted to:  
**UniFirst Corporation**  
68 Jonspin Road  
Wilmington, MA 01887

Prepared by:  
**GEI Consultants, Inc.**  
400 Unicorn Park Drive  
Woburn, MA 01801  
781-721-4000

May 10, 2007, 2007

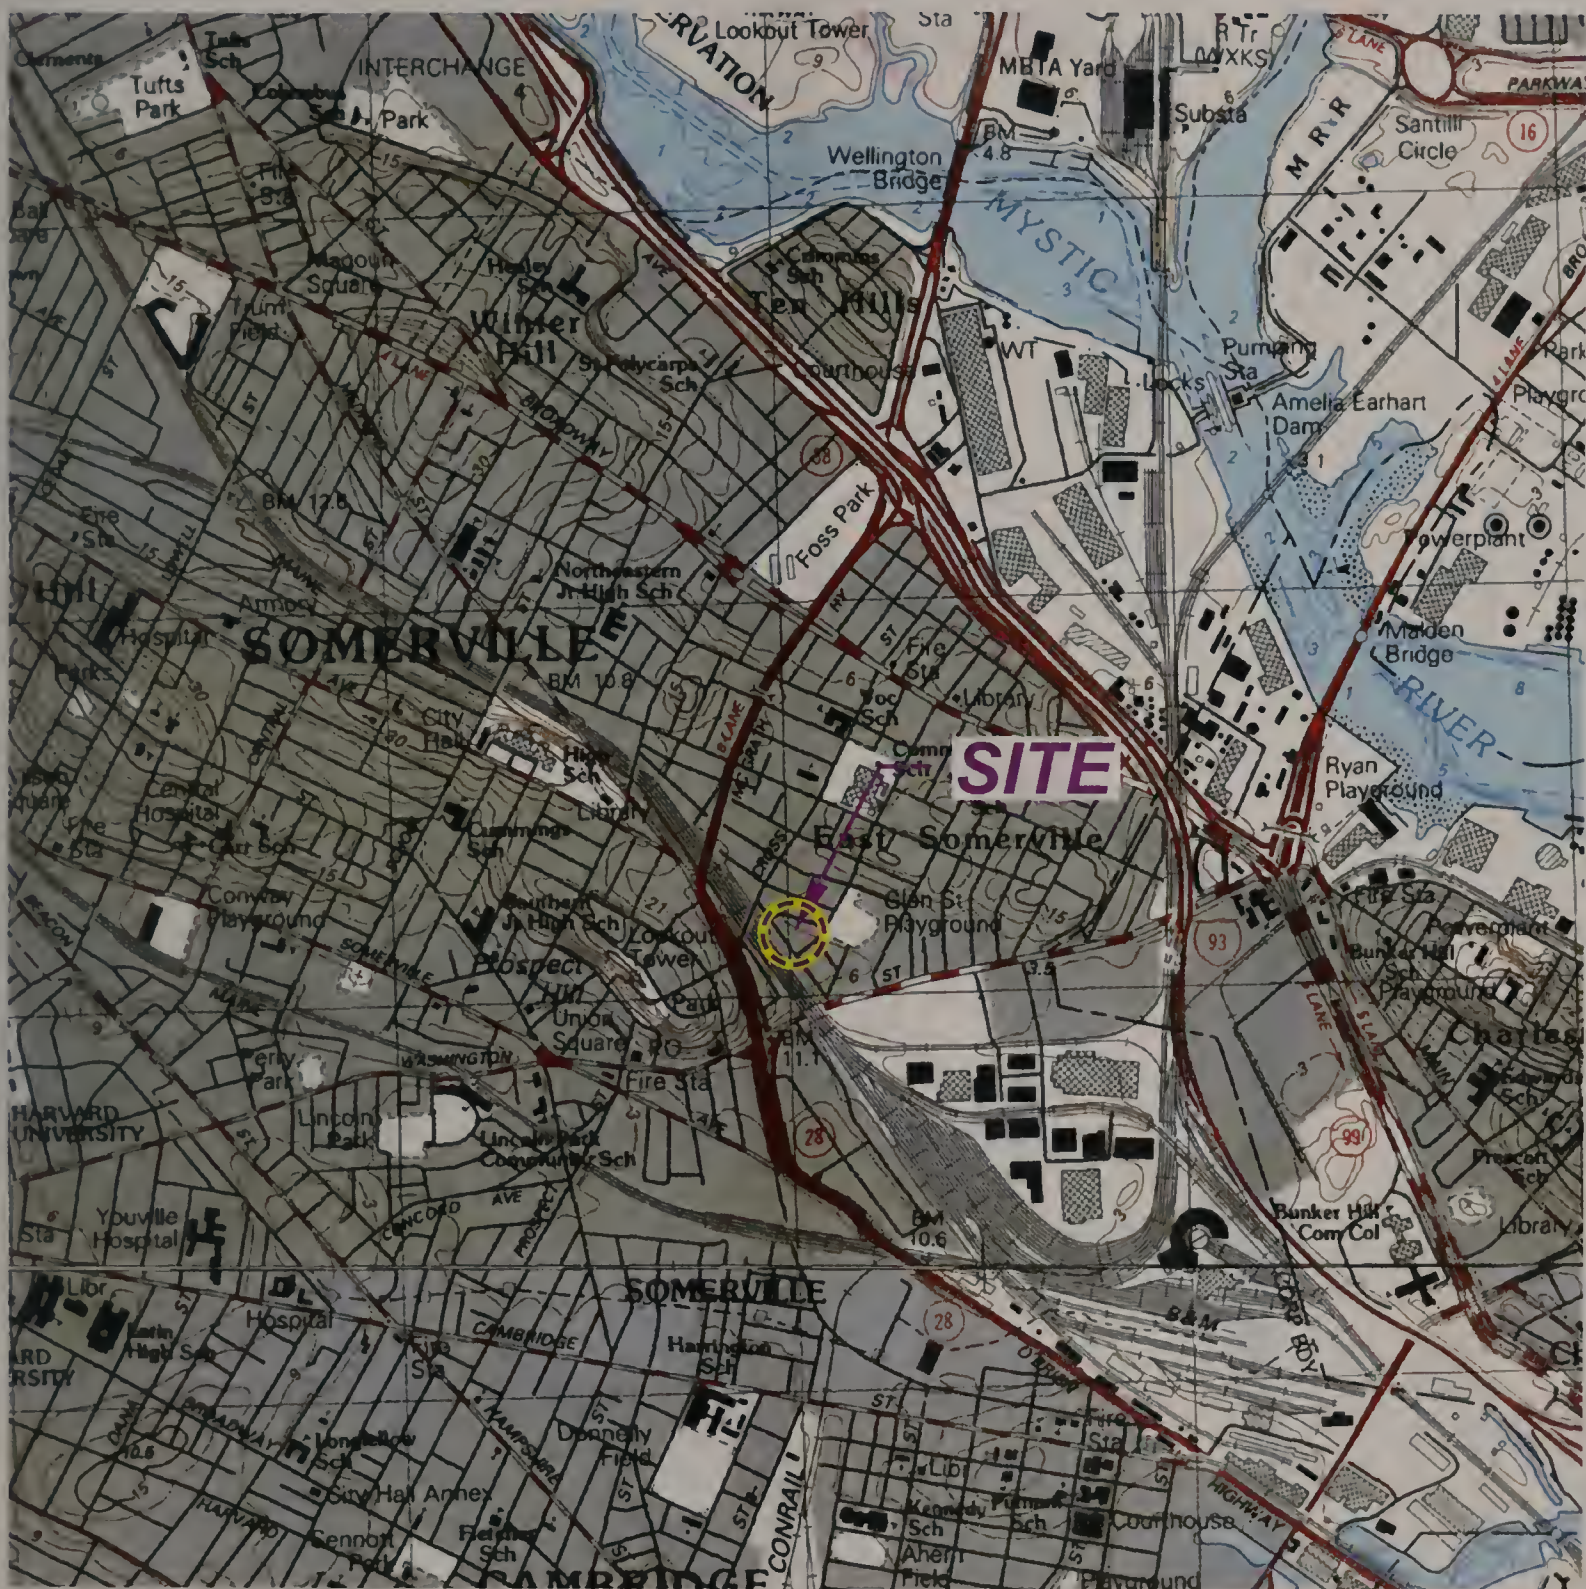
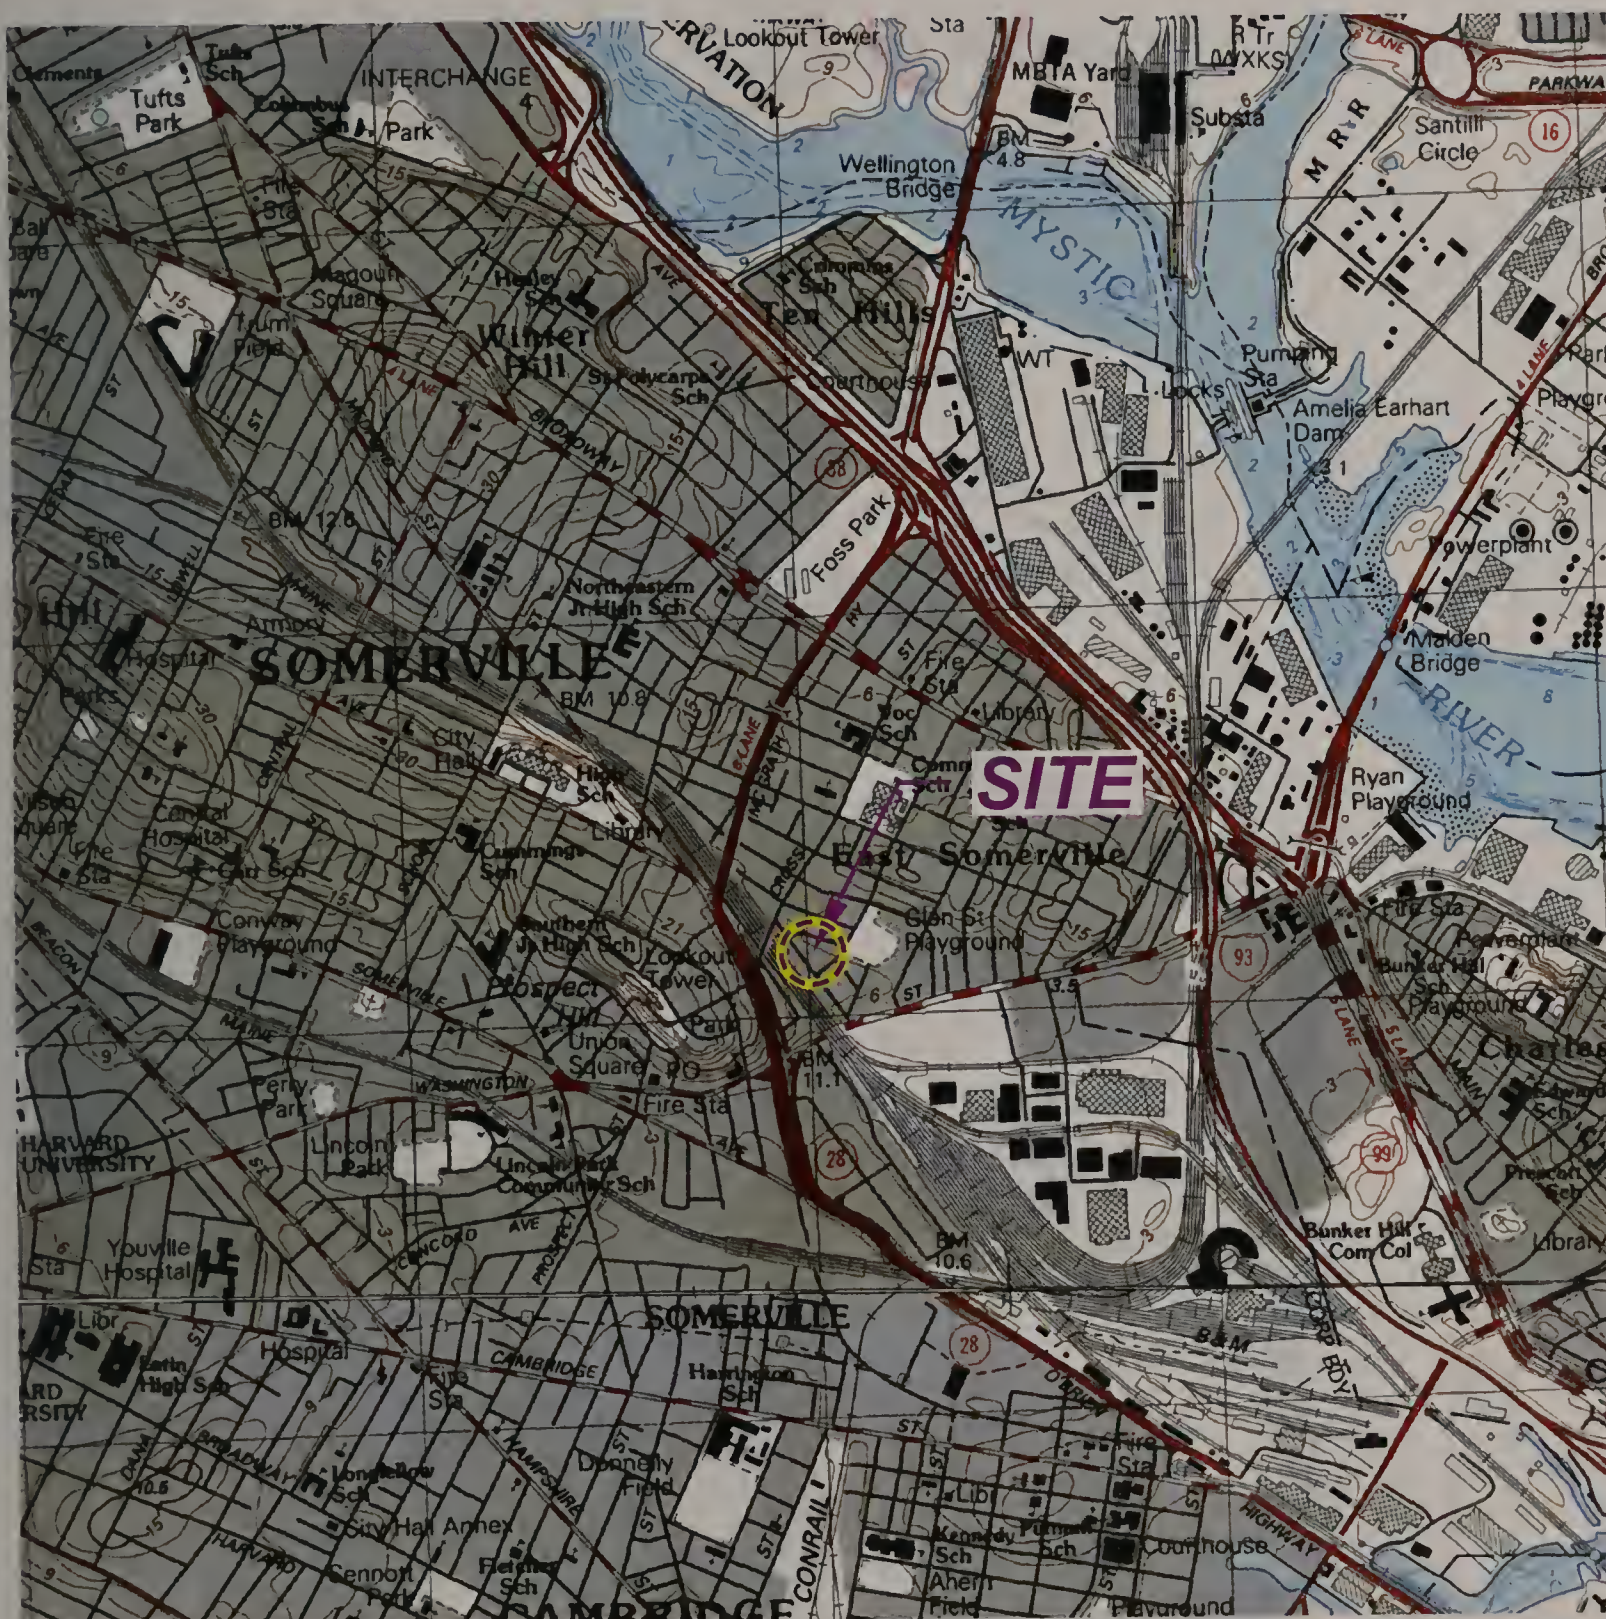
Fig. 1

This Image provided by MassGIS is taken from  
 U.S.G.S. Topographic 7.5 X 15 Minute Series  
 Boston North, MA Quadrangle, 1985.  
 Datum is National Geodetic Vertical Datum (NGVD).  
 Contour Interval is 3 Meters.

On behalf of UniFirst Corporation of Wilmington, Massachusetts, GEI Consultants, Inc. (GEI) prepared this single Immediate Response Action (IRA) Status Report for both RTN 3-26144 (Report No.1) and RTN 3-23246 (Report No.3) for the Site located at 50 Tufts Street in Somerville, Massachusetts (Fig. 1). This IRA Status Report documents activities associated with the 50 Tufts Street Site from September 28, 2006 through March 31, 2007.

On behalf of UniFirst Corporation of Wilmington, Massachusetts, GEI prepared this Immediate Response Action (IRA) Status Report No. 1 and No.3. The work was conducted as part of IRA activities for the Site located at 50 Tufts Street in Somerville, Massachusetts (the Site) (Fig. 1). Based on the results of assessments conducted to date, the Site includes the 50 Tufts Street property (the Property), together with portions of properties in the neighborhoods east and immediately west of the Property, and the Michael E. Capuano Early Childhood Center (Capuano Center) located at 150 Glen Street in Somerville, MA (Figs. 1 and 2). The Property is approximately 51,111 square feet and developed with an approximately 20,594-square-foot, one-story, masonry block building. The majority of the building is warehouse space, and a small portion is office space.

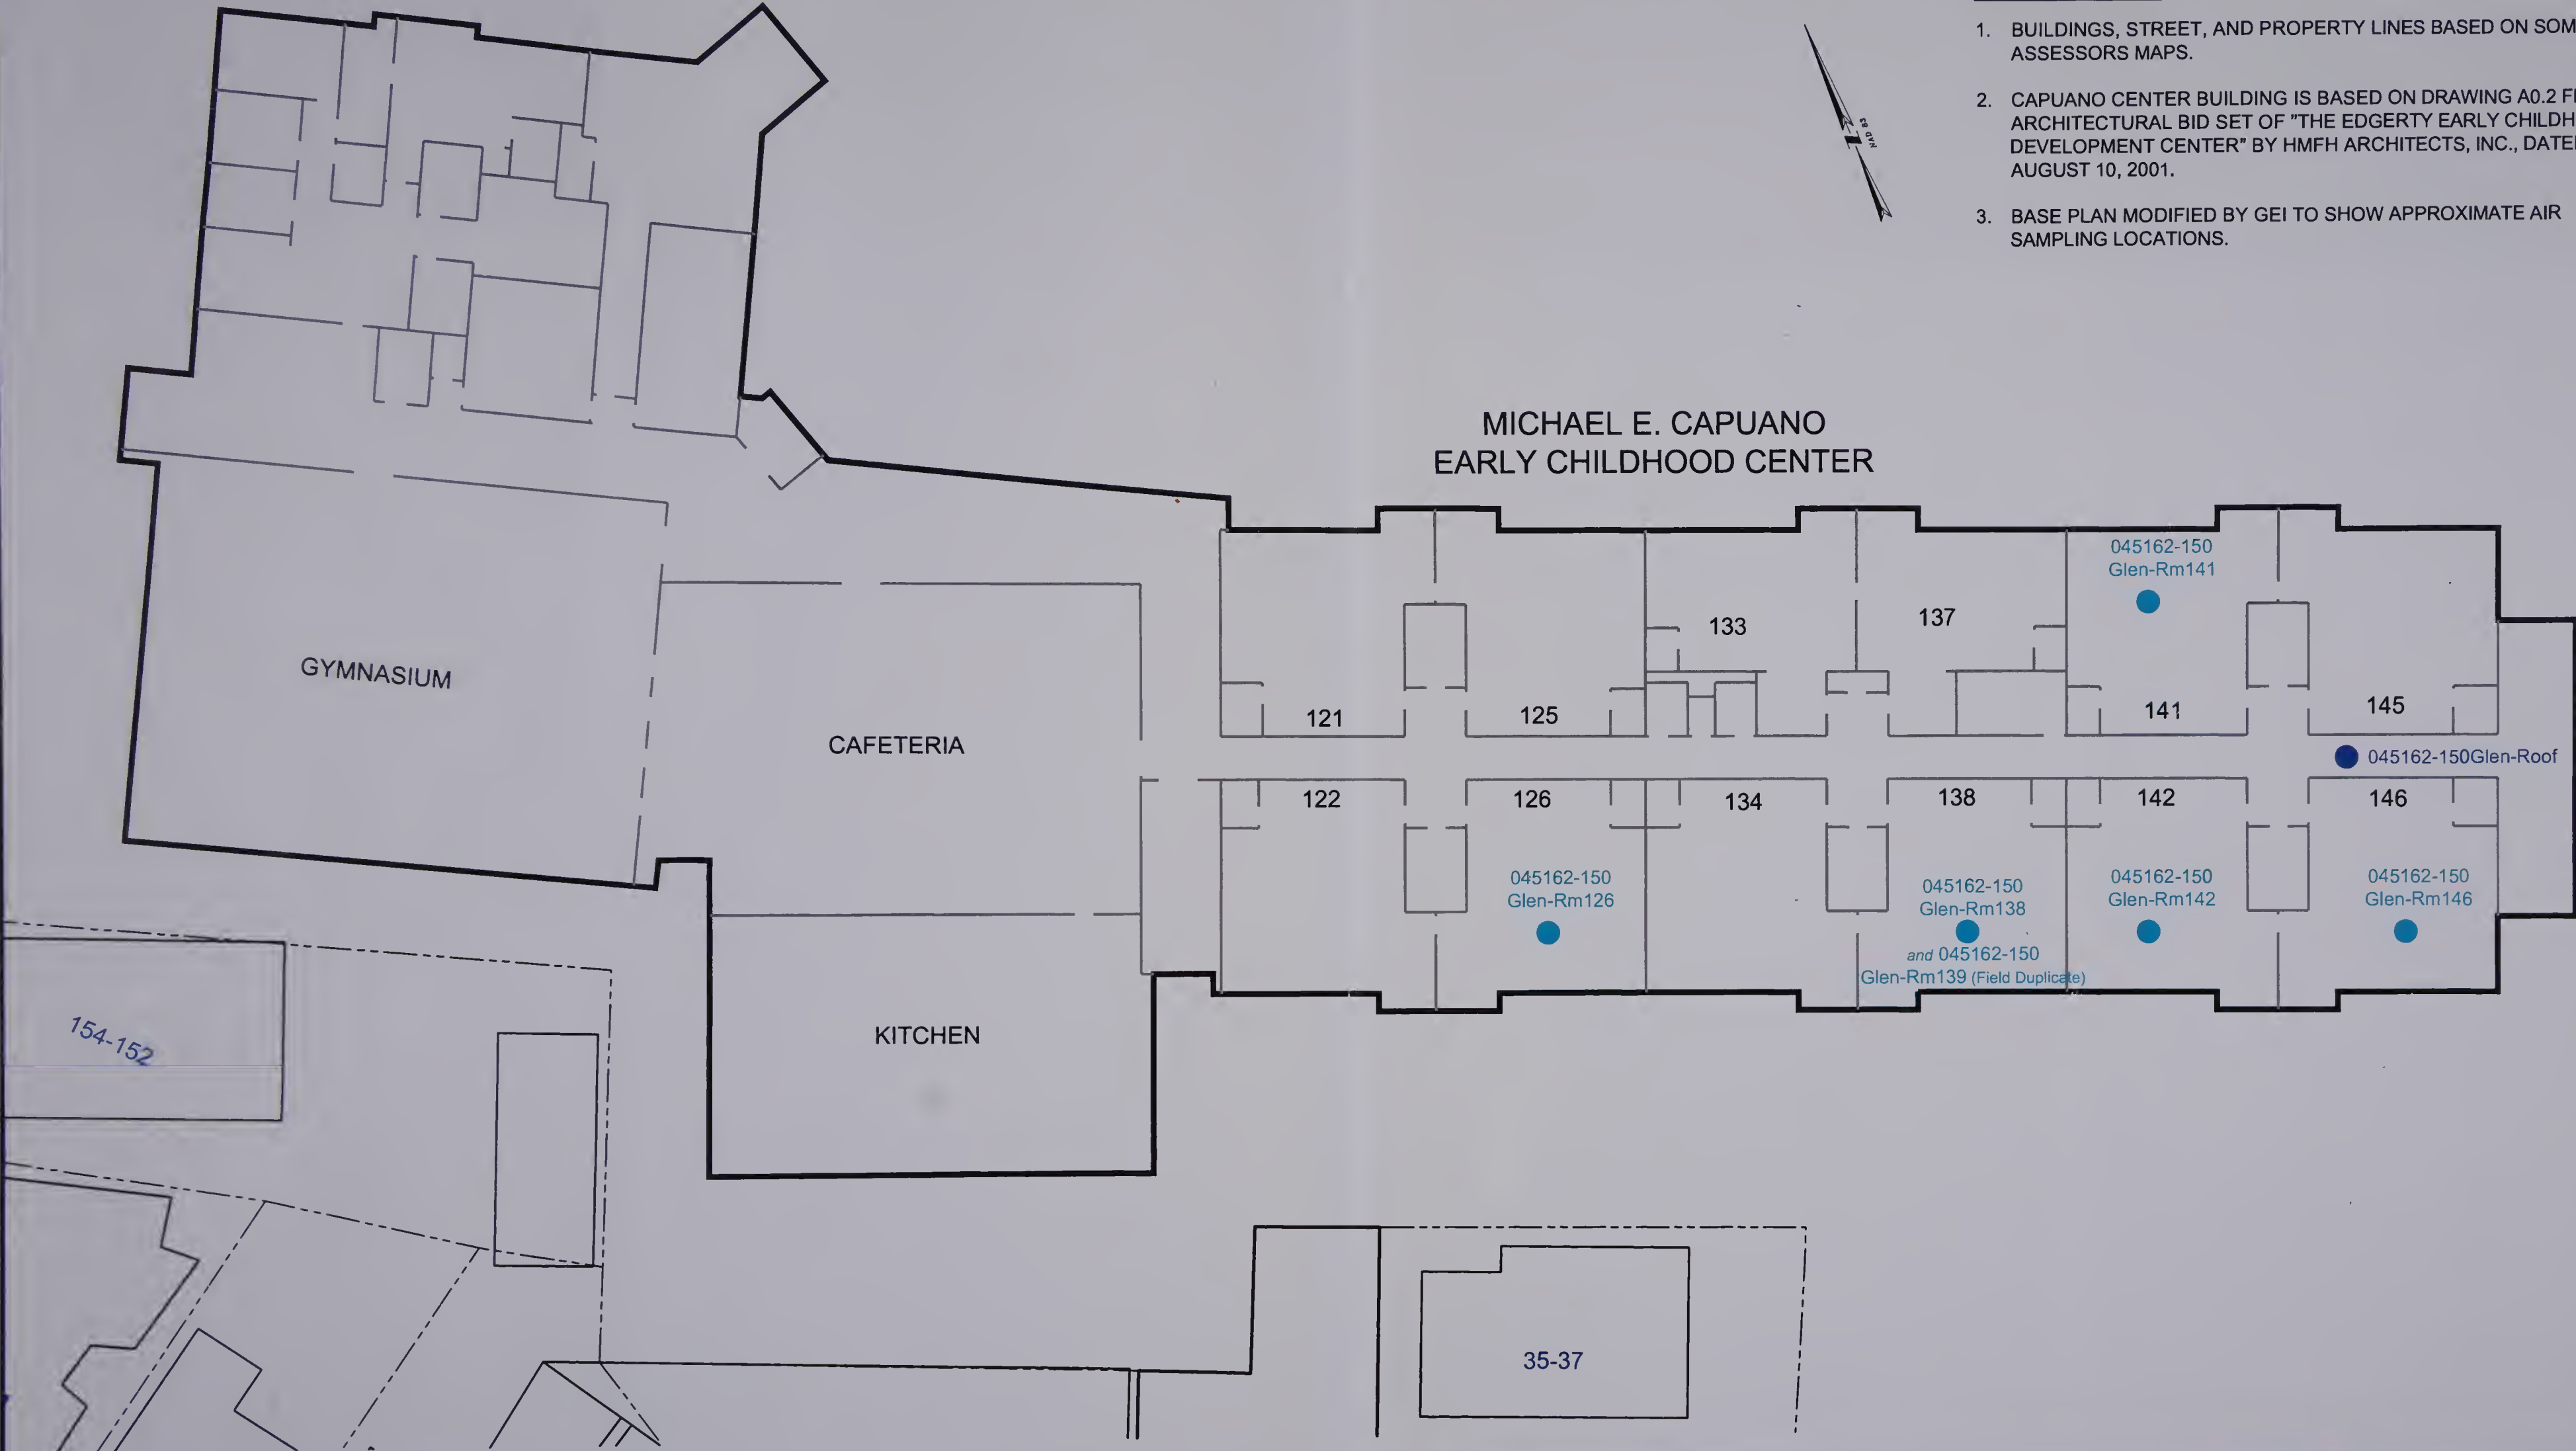
INDOOR AIR SAMPLING LOCATIONS 3/8/07
May 2007
Fig. 11

- LEGEND:**
- INDOOR AIR SAMPLE (4-HOUR SUMMA CANISTER) MARCH 8, 2007
  - OUTDOOR AIR SAMPLE (4-HOUR SUMMA CANISTER) MARCH 8, 2007
  - 138 ROOM NUMBER AT CAPUANO SCHOOL

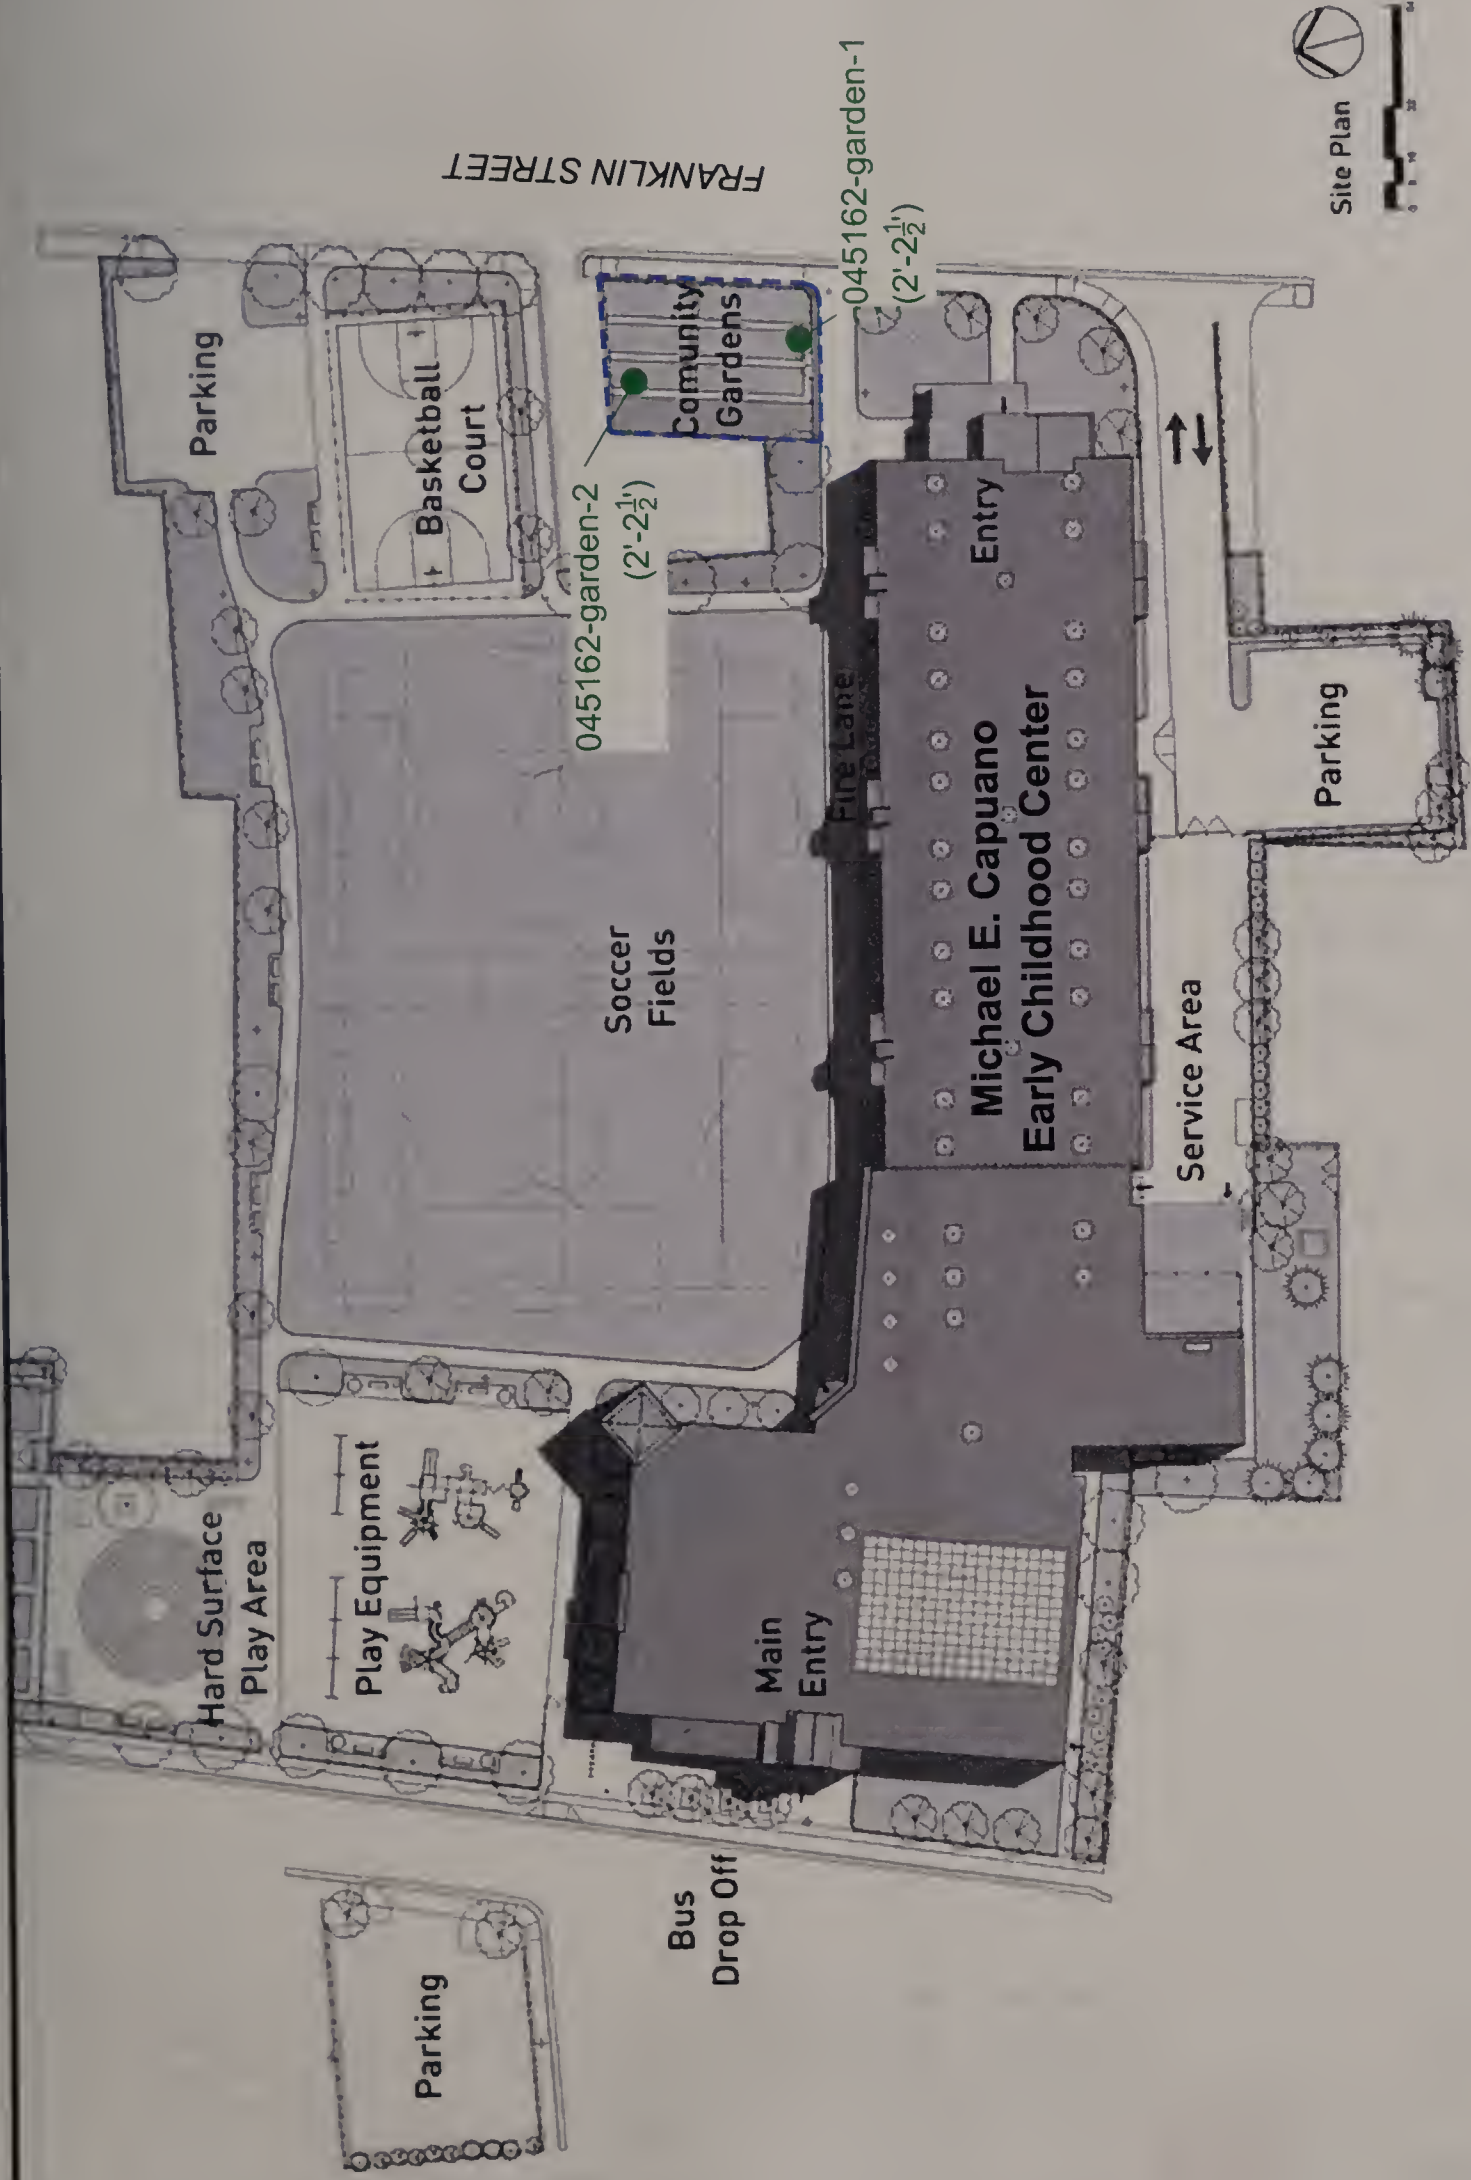
1. BASE IMAGE FROM DESIGNSHARE.COM WEBSITE.
2. BASE IMAGE HAS BEEN MODIFIED BY GEI TO SHOW THE APPROXIMATE GARDEN SAMPLING LOCATIONS.

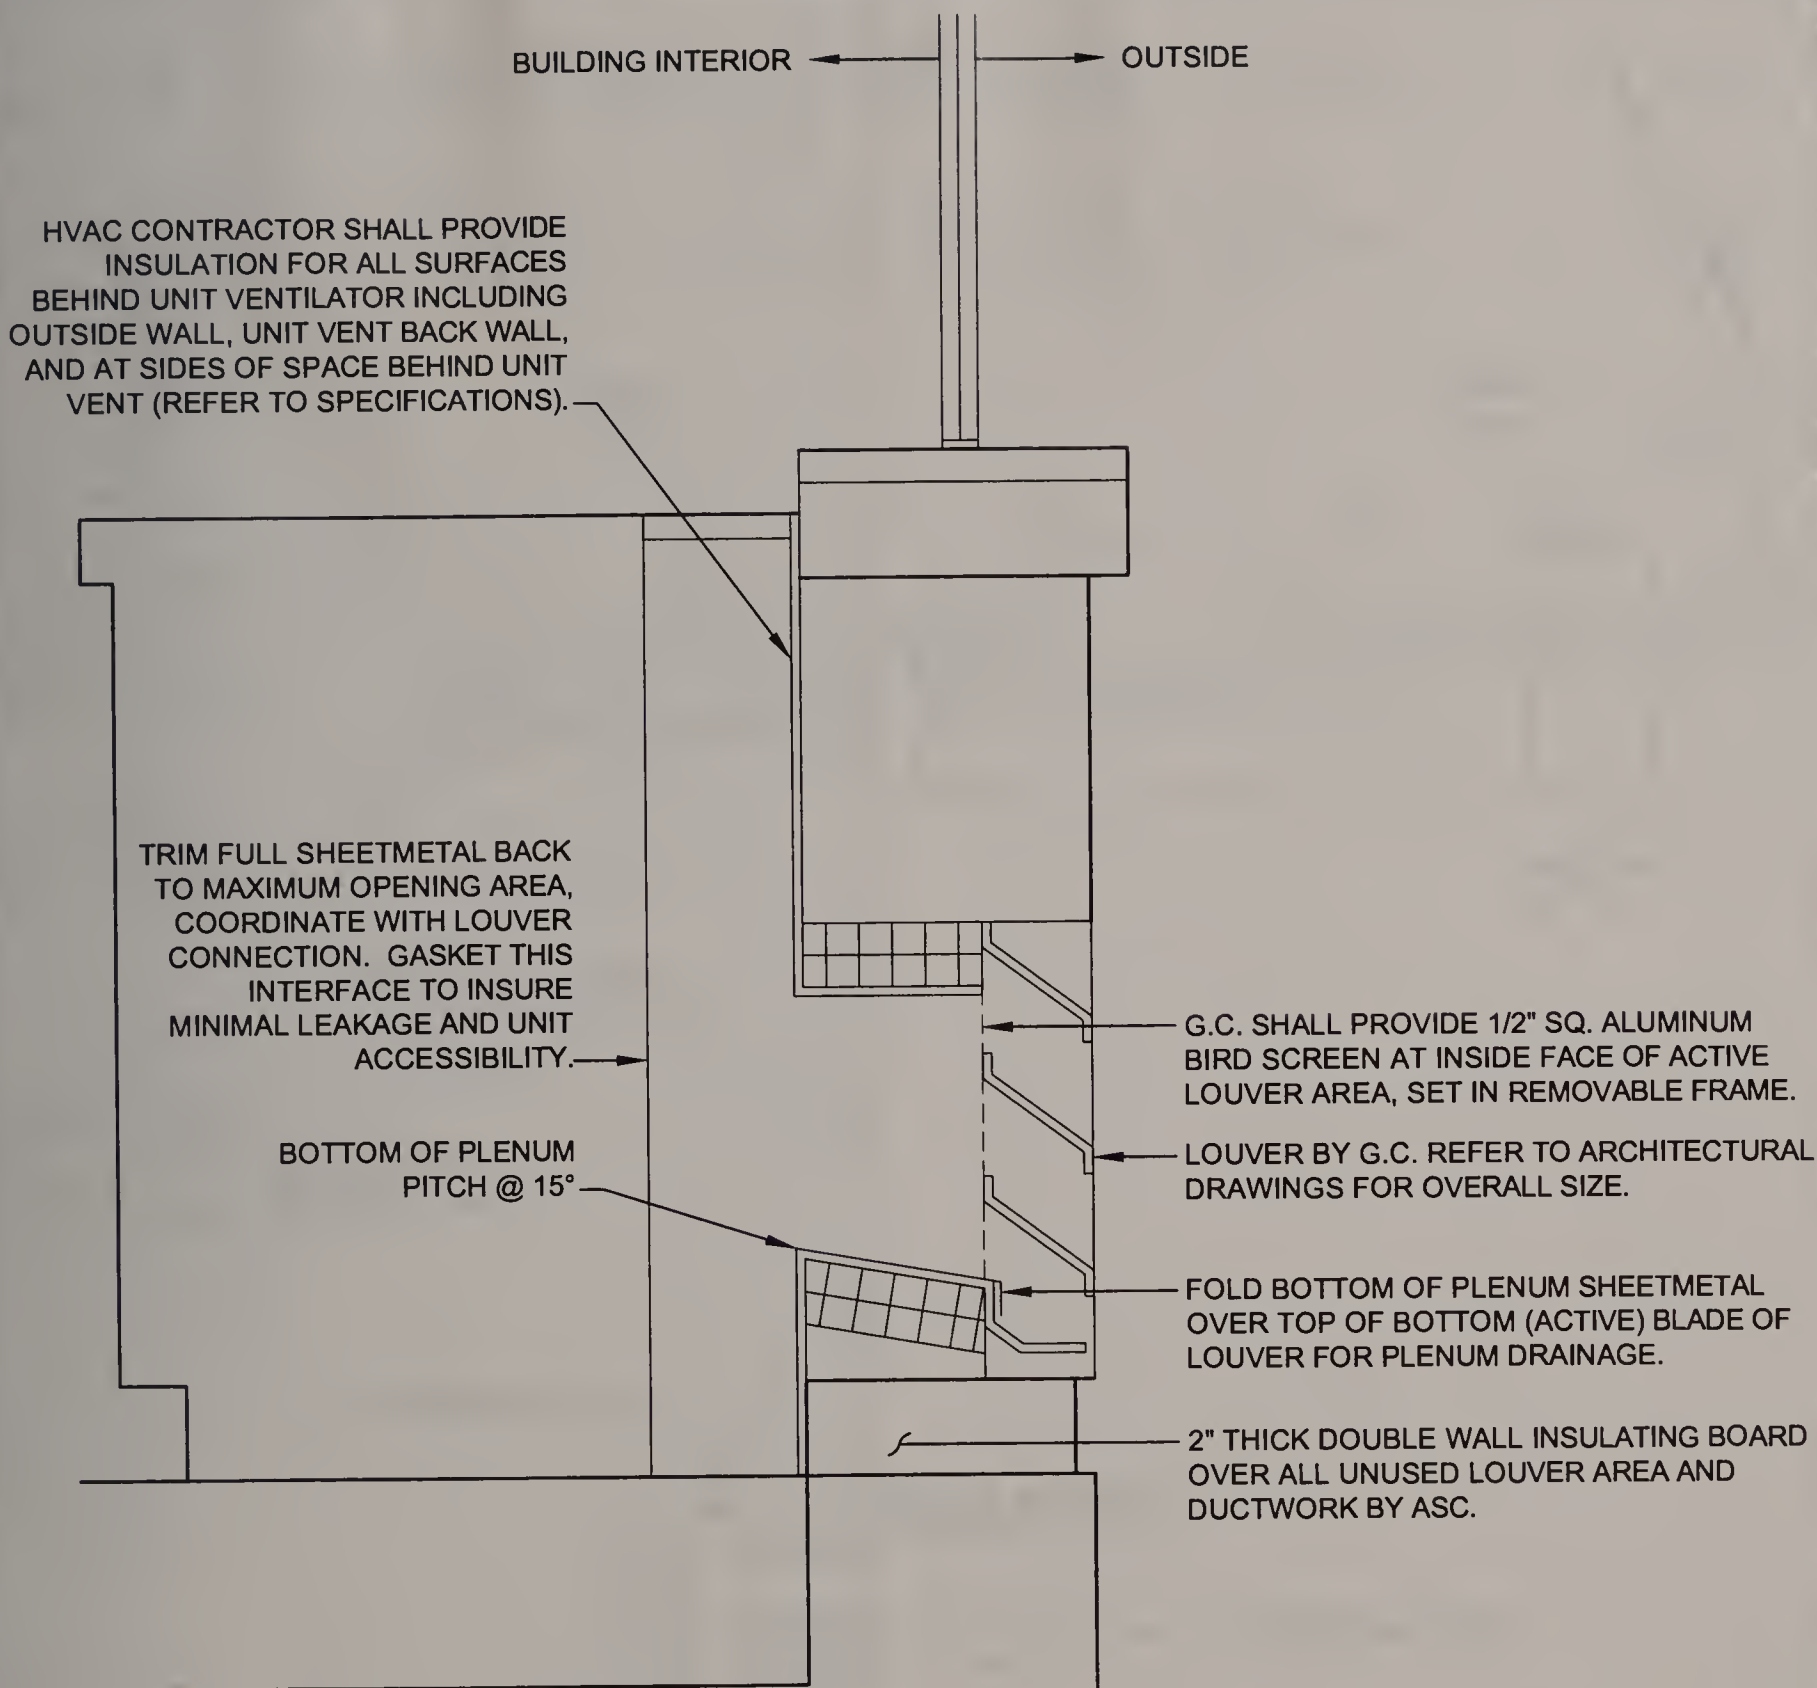
<p>IRA Status Report No. 3 50 Tufts Street Somerville, Massachusetts</p>	<p><b>GEI</b> Consultants</p>	<p>UNIT VENTILATOR CROSS-SECTION</p>	
<p>UniFirst Corporation Wilmington, Massachusetts</p>		<p>May 2007</p>	<p>Fig. 14</p>

**UNIT VENTILATOR**  
(Typical)

Testing conducted by EH&E of the UVs indicated that they were drawing air and associated vapors from the exterior wall cavity through wall penetrations within and behind the UV cabinets. A cross section of the UV design is shown in Figure 14. To reduce this infiltration and

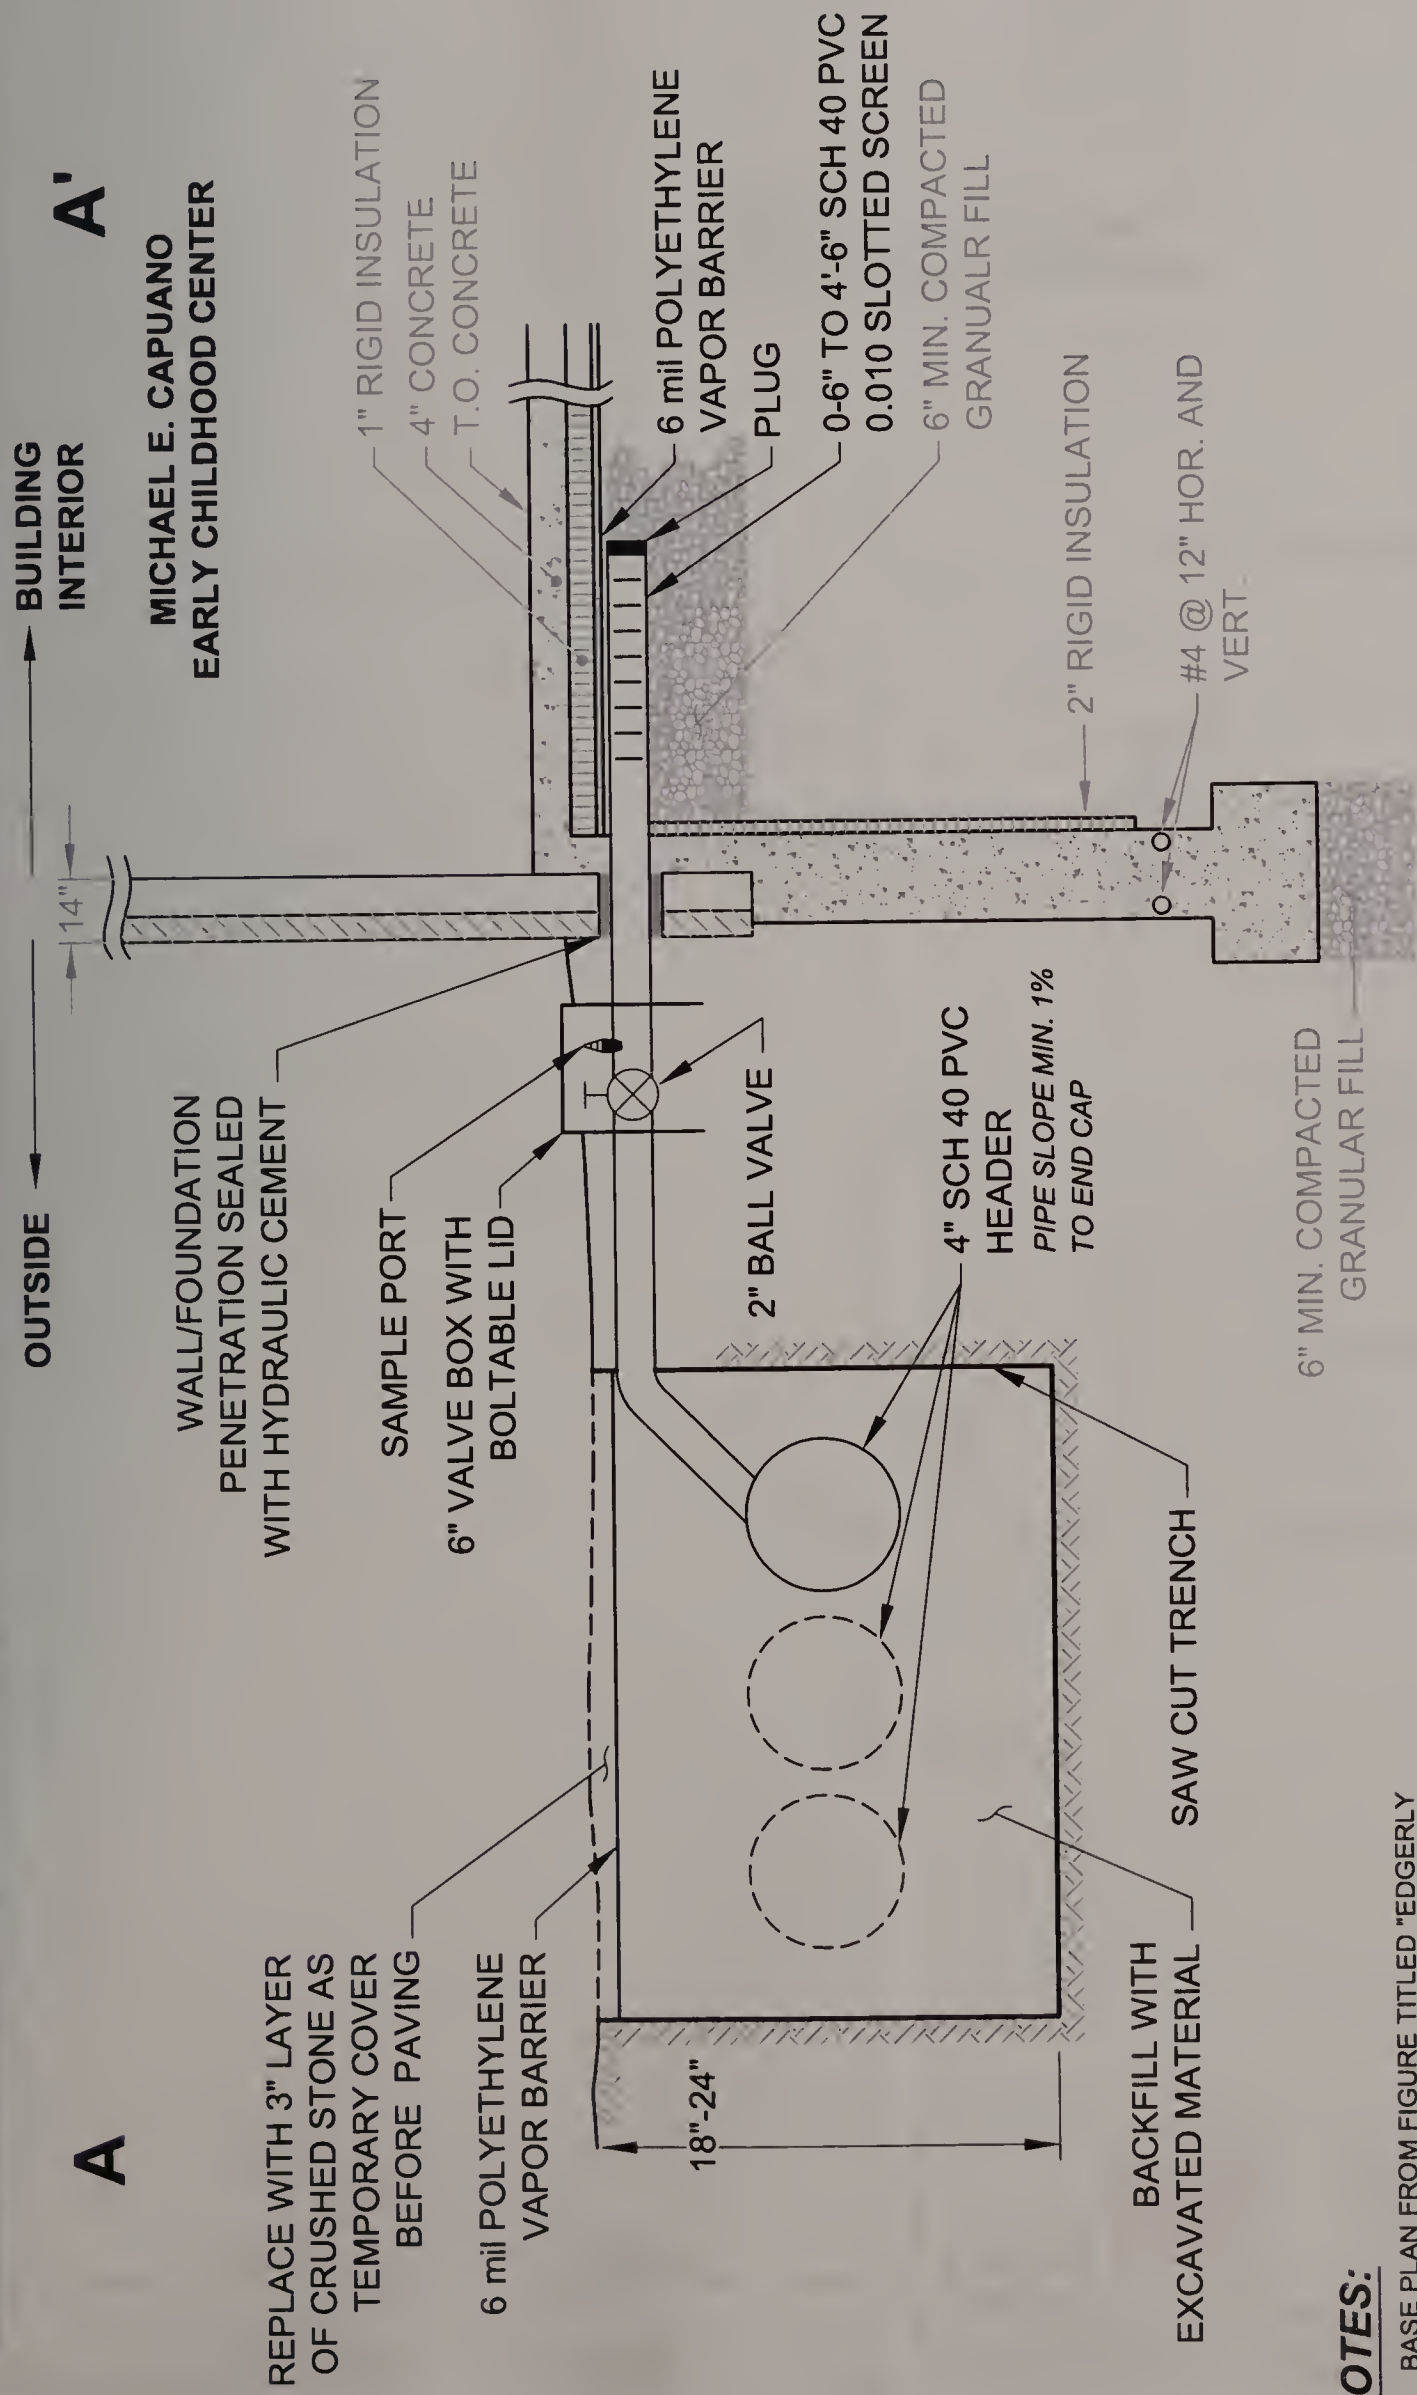
<p><b>GEI</b> Consultants</p>	<p>TRENCH EXCAVATION AND WALL PENETRATION DETAILS</p>
<p>Project 04516-2</p>	<p>May 2007</p>	<p>Fig. 17</p>

1. BASE PLAN FROM FIGURE TITLED "EDGERLY EARLY CHILDHOOD DEVELOPMENT CENTER SOMERVILLE, MASSACHUSETTS FOUNDATION SECTIONS" BY HMFH ARCHITECTS DATED 08/10/2001.
2. BASE PLAN HAS BEEN MODIFIED BY GEI TO SHOW THE APPROXIMATE LOCATION AND DETAILS OF PORTIONS OF THE SSDS COMPONENTS

- Excavation of a 2-foot deep trench adjacent to the foundation of the building from Classroom 122 to Classroom 146. The trench was approximately 3-feet wide and required removal of the paved sidewalk.

- Coring 3-inch diameter holes through the foundation wall from outside of the building that penetrated approximately 6-feet into the fill beneath the concrete floor slab.

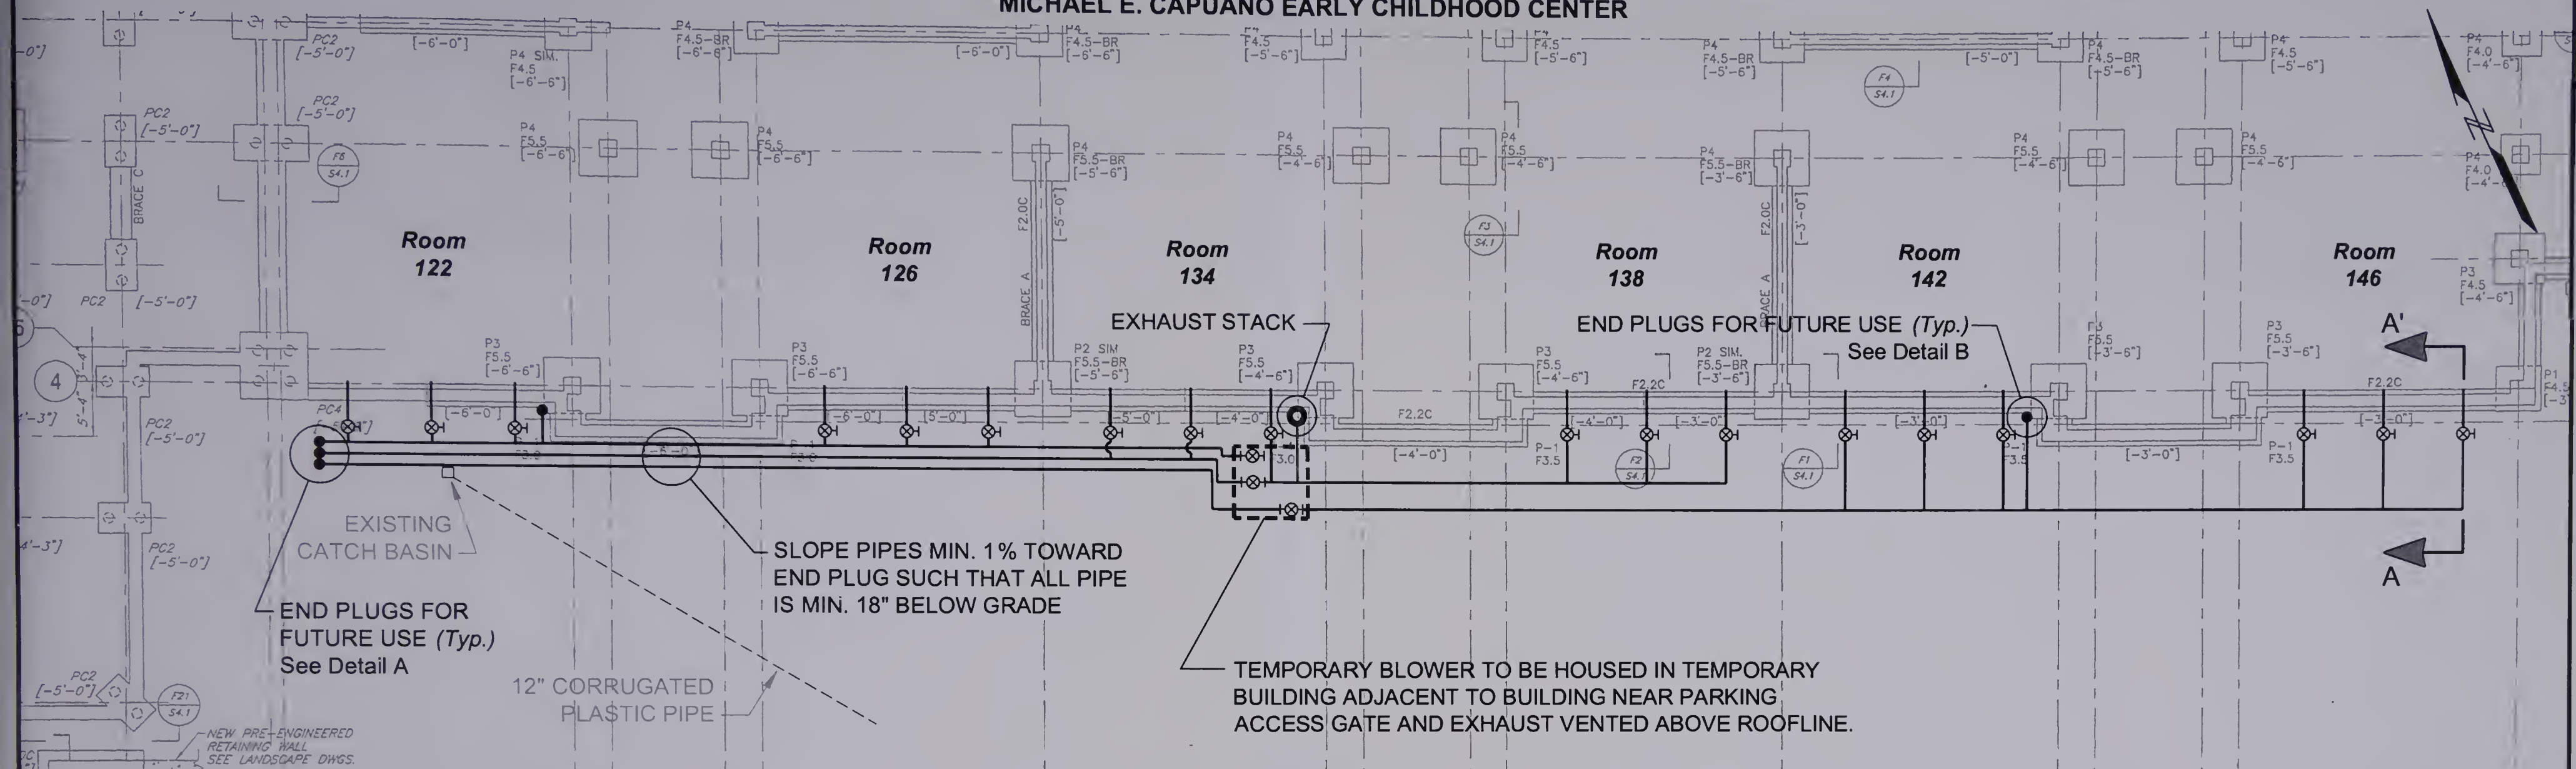
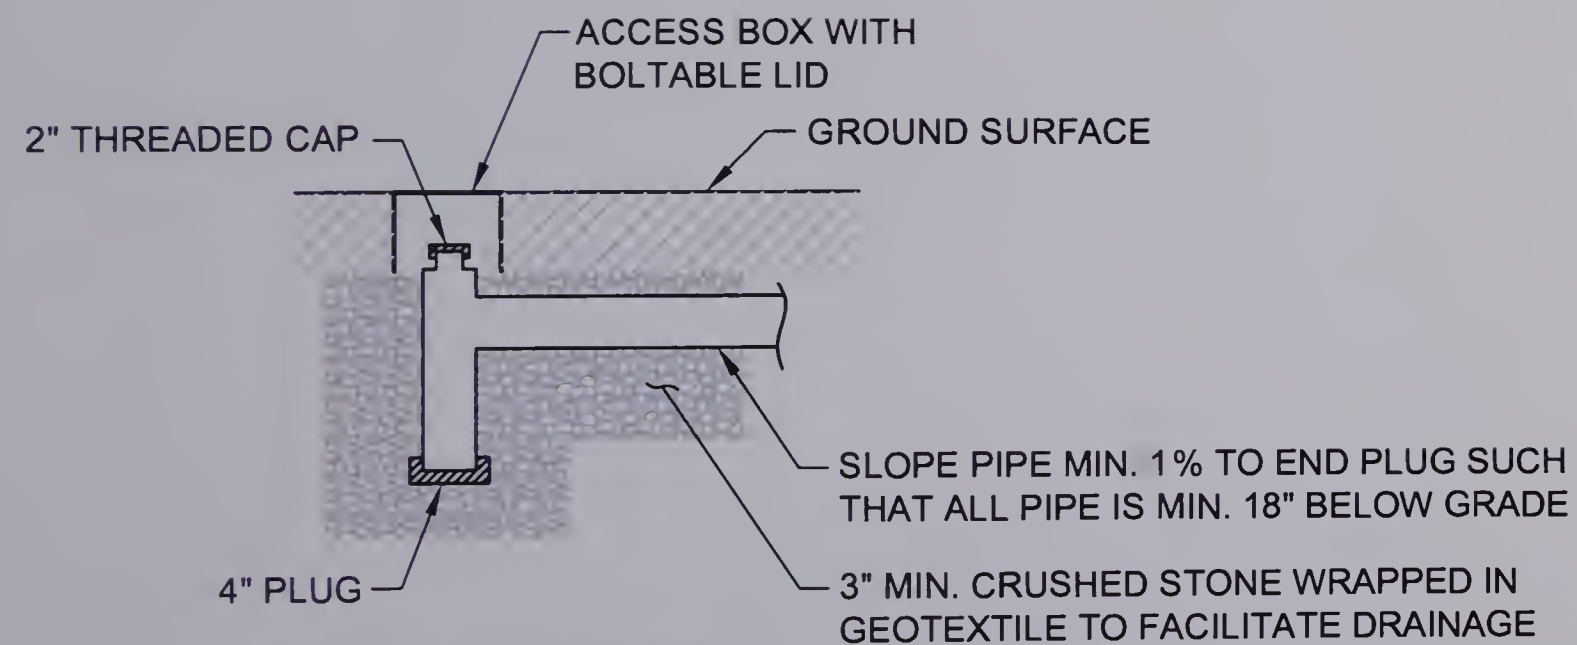
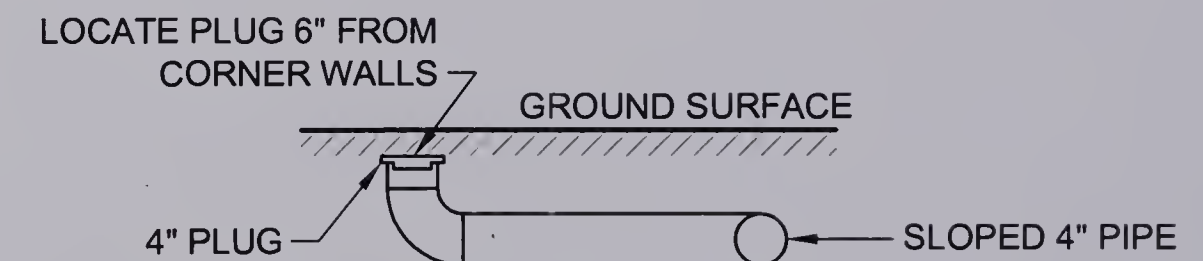
Fig. 15

**PLAN**  
Not To Scale

**DETAIL A**  
Not To Scale

**DETAIL B**  
Not To Scale
